December 13, 2018

**RE: Letter in Support of Removal of Tree, Shed, and Fire Hydrant from the ESHA for Fuel Tank Demolition Project at 3300 Panorama Drive, Morro Bay, California.**

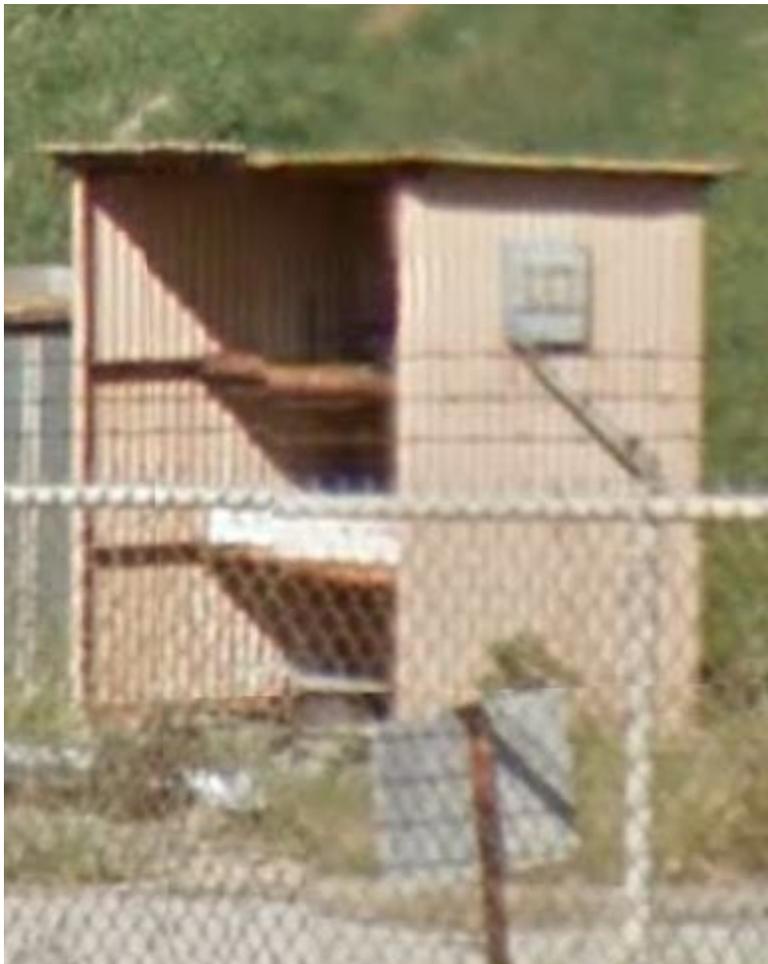
A shed (Photo 3), with dimensions 4.5' x 6.5' and 7' tall with a roof that is 5.5'x7.5', along with a nearby fire hydrant are planned for removal from the ESHA zone. The shed and fire hydrant can be accessed with minimal impact to the ESHA from Tuscan Ave (Figure 3) where any equipment and vehicles will be stationed. When removing the shed and fire hydrant they will be accessed by foot and only hand tools will be used. The water pipe to the fire hydrant can be capped and left in place. A bucket truck or any like equipment can be used to remove the structures from over the fence while staged on Tuscan Ave. Any signs of anthropological activity should be raked out and cleaned up. All shed removal activity should be monitored by a qualified biologist. The concrete pad that the shed sits on will not be removed. A recent biological survey of nearby trees has shown that there are no active bird nests, nesting behavior, or roosting, and the removal of the shed will occur outside of nesting season.

Photo 3. Shed
