City of Morro Bay's - Pavement Management Plan, June 2011

PAVEMENT MANAGEMENT PLAN (PMP)  
FOR  
THE CITY OF MORRO BAY

June 2011

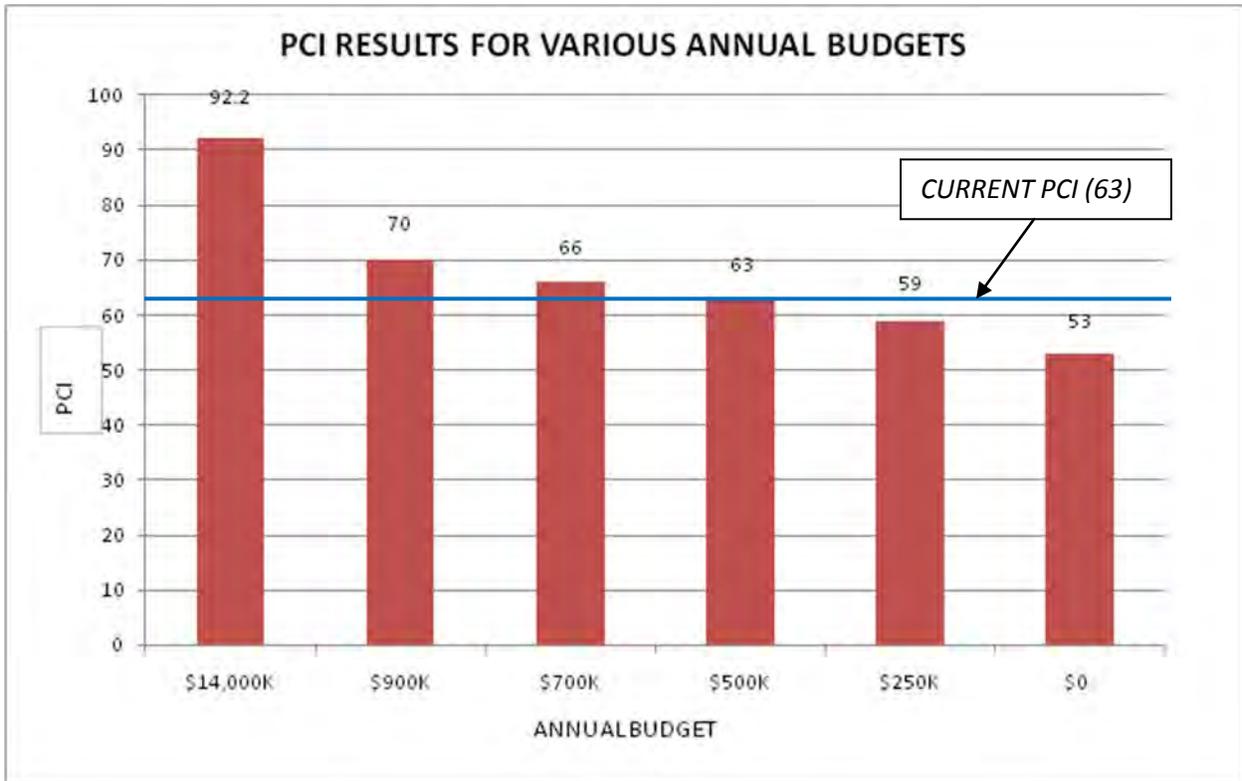
As part of the analysis, the anticipated PCI at various budget levels over 10 years was projected using the MicroPAVER software. The analysis showed that a yearly funding level of about \$500,000 is required to maintain the street system at its current average condition and it would require \$900,000 annually to increase the overall PCI to 70. Anything less than \$500,00 will mean continued degradation of pavement conditions in the City. The analysis is summarized on the graph below.

- The \$14 Million budget amount is the total expenditure required to provide all recommended repairs.

The annual programs were developed utilizing the MicroPAVER calculated PCI and pavement management priorities outlined above. An effort was also made to group streets by treatment type and geographical location. The optimal annual budget for a program that complies with the policy recommendations of this report is \$900,000. Plans for a \$500,000 and \$250,000 annual budget have also been developed, as well as a budget that spends \$900,000 in the first year, followed by \$250,000 annually thereafter.
